University of Queensland Experimental Mine

**Notification of Notifiable Activity and Contaminated
Land Supporting Report**

27 September 2013

Prepared by The Sustainability Office, Property and Facilities Division

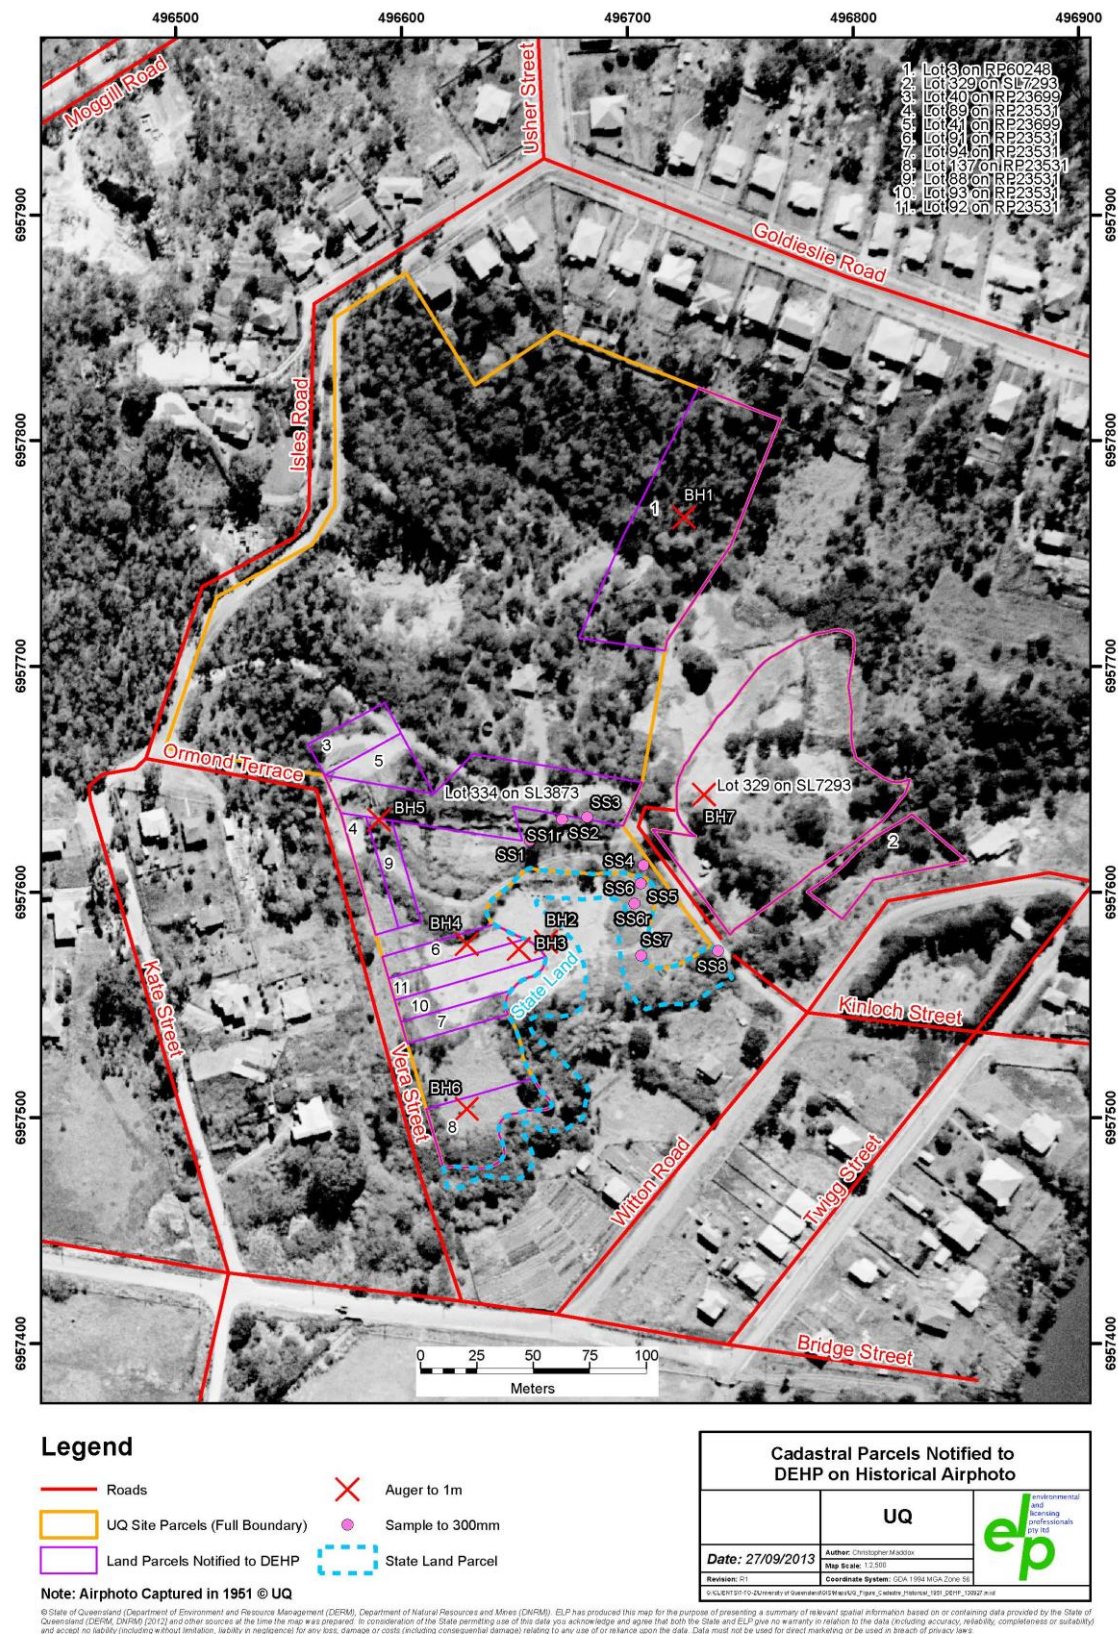
Figure B.1. Aerial Photograph indicating the UQEM lots, and lots determined as having been used for a notifiable activity and being contaminated.

- The 1951 aerial photograph (with reference to Figure B.1. in Appendix B) shows definite contrast between different surface coverings on the site. Some of the recent soil sample locations are consistent with clearly disturbed areas on this photograph. It is reasonable to assume these areas indicate interference with the natural landscape.

From the above, UQ has concluded that during operations at the mine, it is likely waste materials have migrated or been placed on the nominated lots, defined by the clearly disturbed areas in the aerial photograph and/or by soil sampling results.

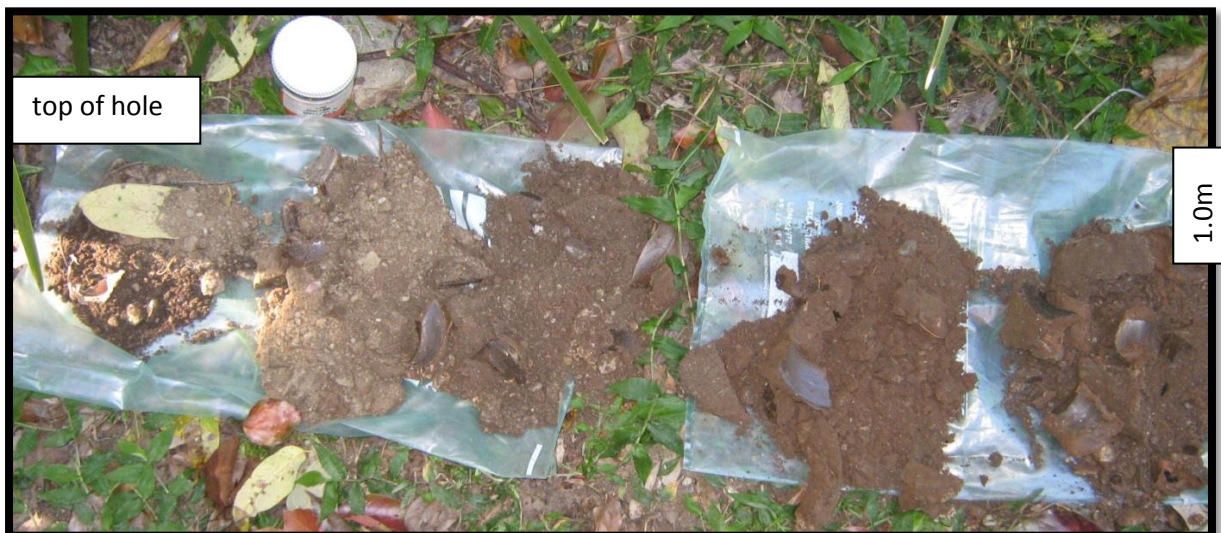
Depth From	Depth To	Group Symbol	Description	Moisture	Consistency	Comment
0	0.2	SM	Loamy Sand, soil, brown , fine grained	Dry	Loose	
0.2	0.4	CL	Light Clay, pale brown	Dry	Loose	sampled
0.4	0.6	CL	As above, minor rock chips	Dry	Loose	
0.6	1.0	CL	Clay, Brown	Dry	Firm	Firm but crumbly. Looks like natural soils. Sample at 0.6m

Figure 0-1 BH1 Soils Photo

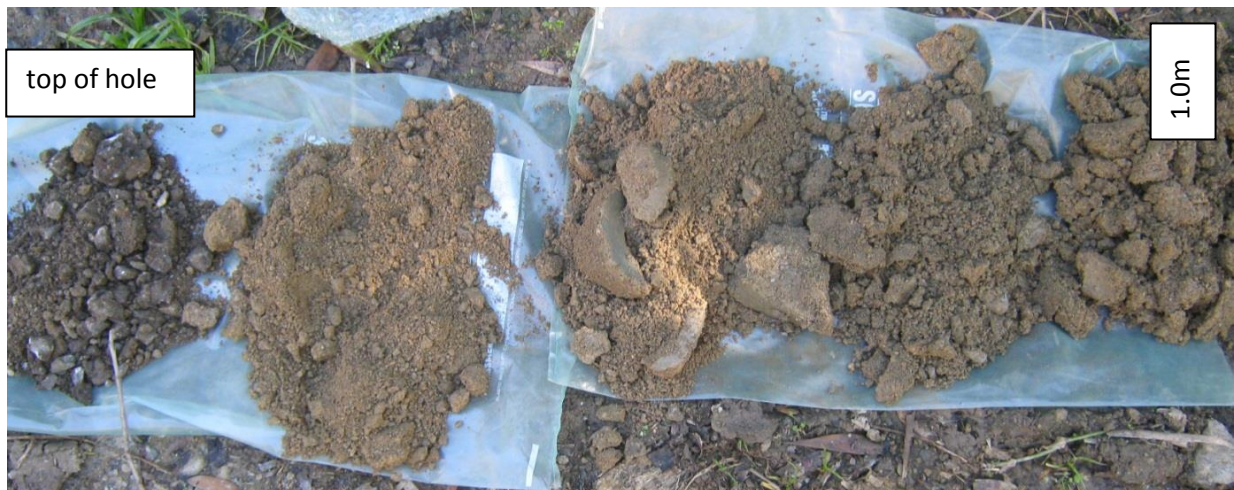
Depth From	Depth To	Group Symbol	Description	Moisture	Consistency	Comment
0	0.2	GC	Gravel with sand, Brown	Dry	Loose	
0.2	0.4	SC	Sand, with Clay, pale brown	Moist	Loose	Looks like “deco”. sampled
0.4	0.6	SC	Sand, with Clay and minor gravel, pale brown	Moist	Loose	
0.6	1.0	SC	Sand, with Clay, pale brown	Wet	Loose	Sample at 0.6m. Essentially all the same material from 0.2m down hole.

Figure 0-2 BH2 Soils Photo

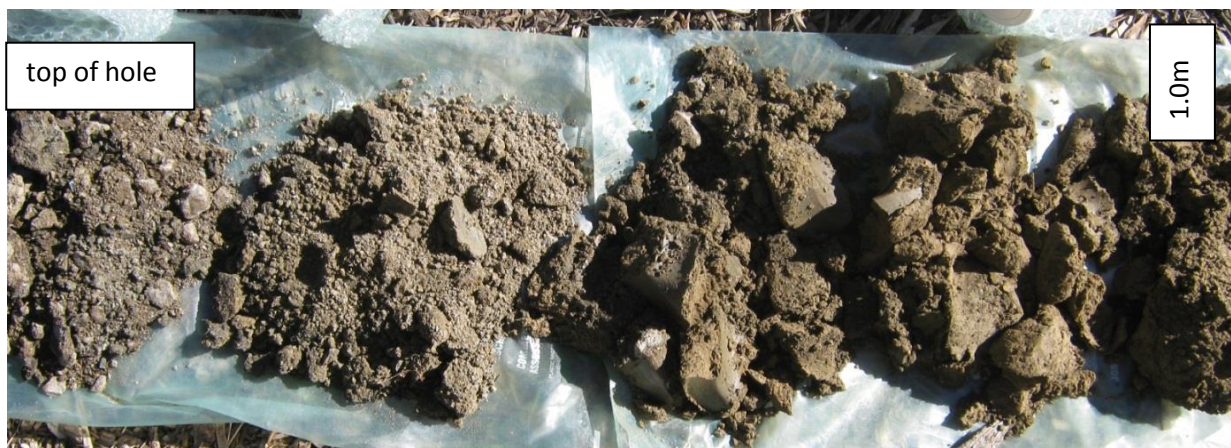
Depth From	Depth To	Group Symbol	Description	Moisture	Consistency	Comment
0	0.2	GC	Gravel, clayey, with sand, brown	Dry	loose	Sampled at 0.1m
0.2	0.4	SC	Sand, clayey, light brown	Dry	Loose	Gravelly at top. Sampled at 0.2m
0.4	0.6	SC	Sand, clayey, minor gravel, light to medium brown	Dry	Loose	
0.6	0.8	CH	Clay, brown.	Moist	Soft	No sand. Does not look like natural clay. Sample at 0.6m
0.8	1.0	SC	Sand, clayey, brown	Wet	Loose

Figure 0-3 BH3 Soils Photo

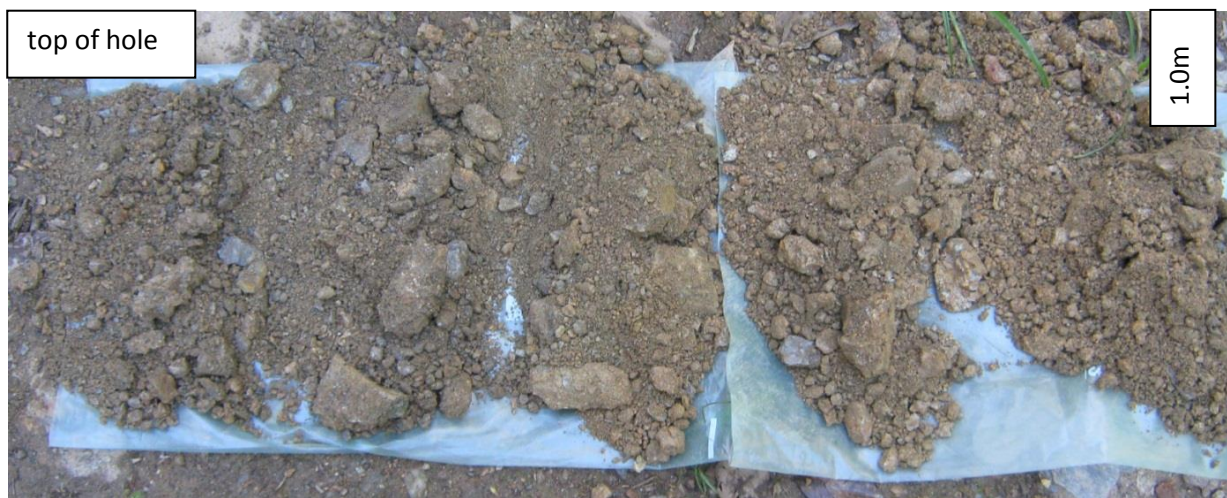
Depth From	Depth To	Group Symbol	Description	Moisture	Consistency	Comment
0	1.0	GC	Gravel, clayey, tan brown	Moist	Loose	Looks like all fill materials. Samples at 0.1, 0.2, 0.8m.

Figure 0-4 BH5 Soils Photo

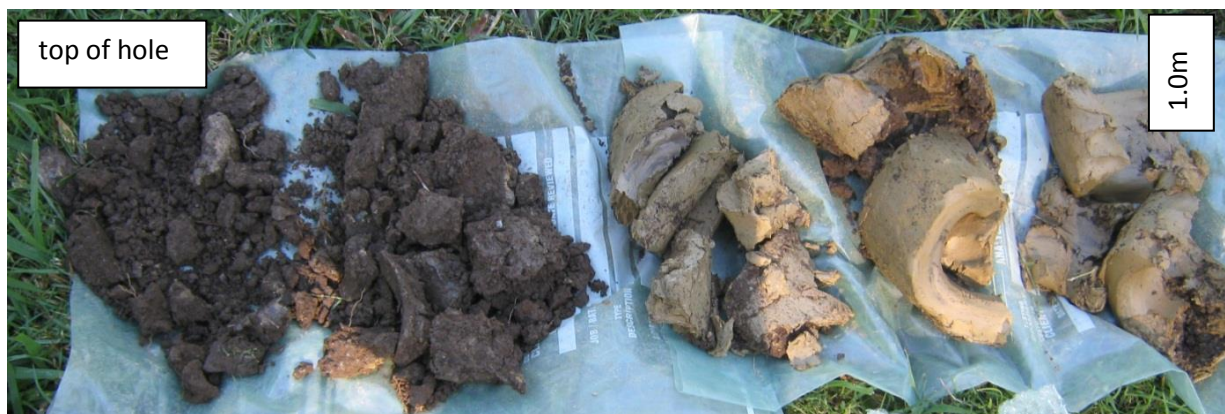
Depth From	Depth To	Group Symbol	Description	Moisture	Consistency	Comment
0	0.4	CH	Clay, dark brown	Moist	Soft	Looks natural. Sample at 0.2m
0.4	1.2	CH	Clay, light brown	Moist	Very Soft	Very sharp contrast in colour and texture with the interval above. Does not appear like natural clay. Sample at 0.4, 0.6, 0.8, 1.0m
1.2	1.4	CH	Clay, brown, with some light brown clay	Moist	Soft to Firm	Transitional unit. Sample at 1.2m
1.4	2.0	CH	Clay, brown with minor very fine orange mottle	Moist	Soft	Looks like natural clay

Figure 0-5 BH6 Soils 0 to 1.0m Photo

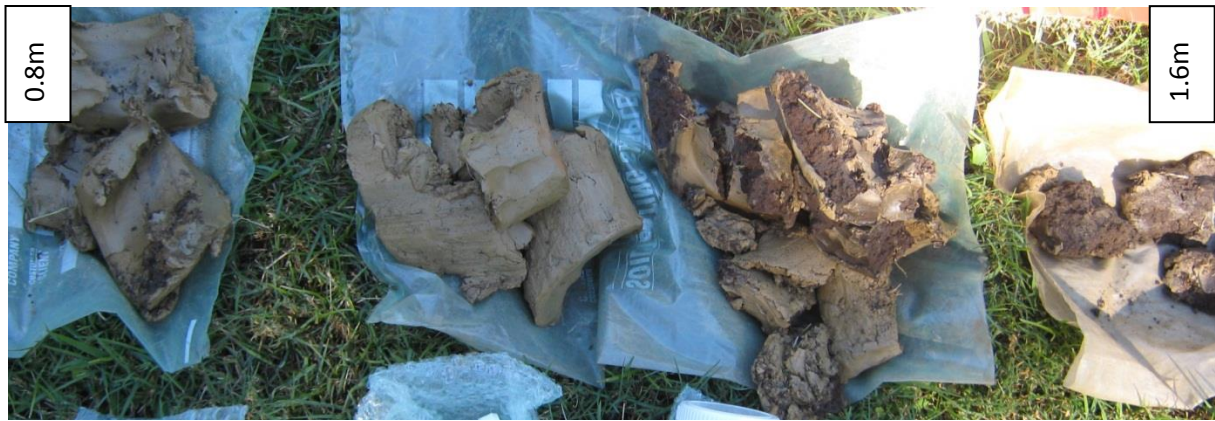
Figure 0-6 BH6 Soils 0.8 to 1.6m Photo

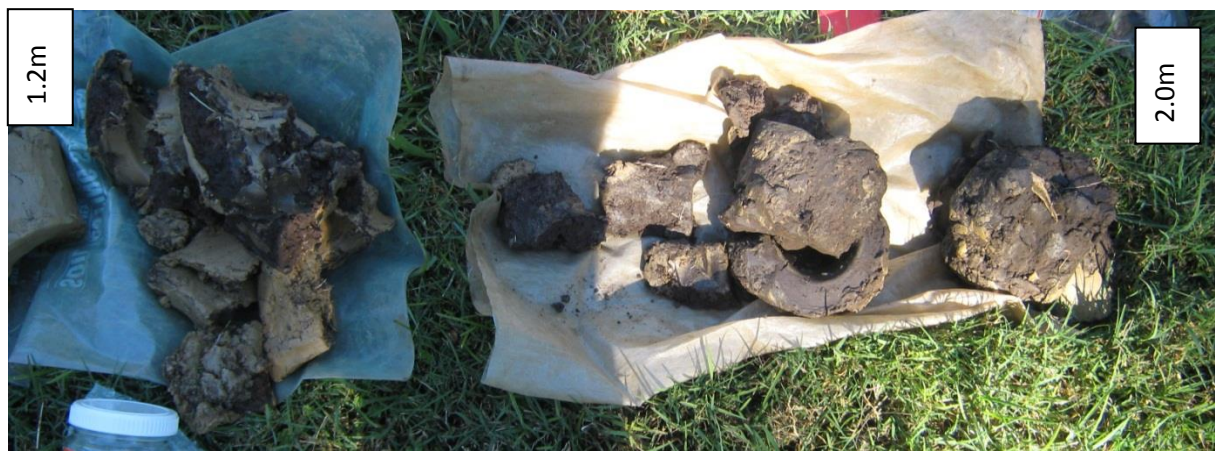
Figure 0-7 BH6 Soils 1.2m to 2.0m Photo

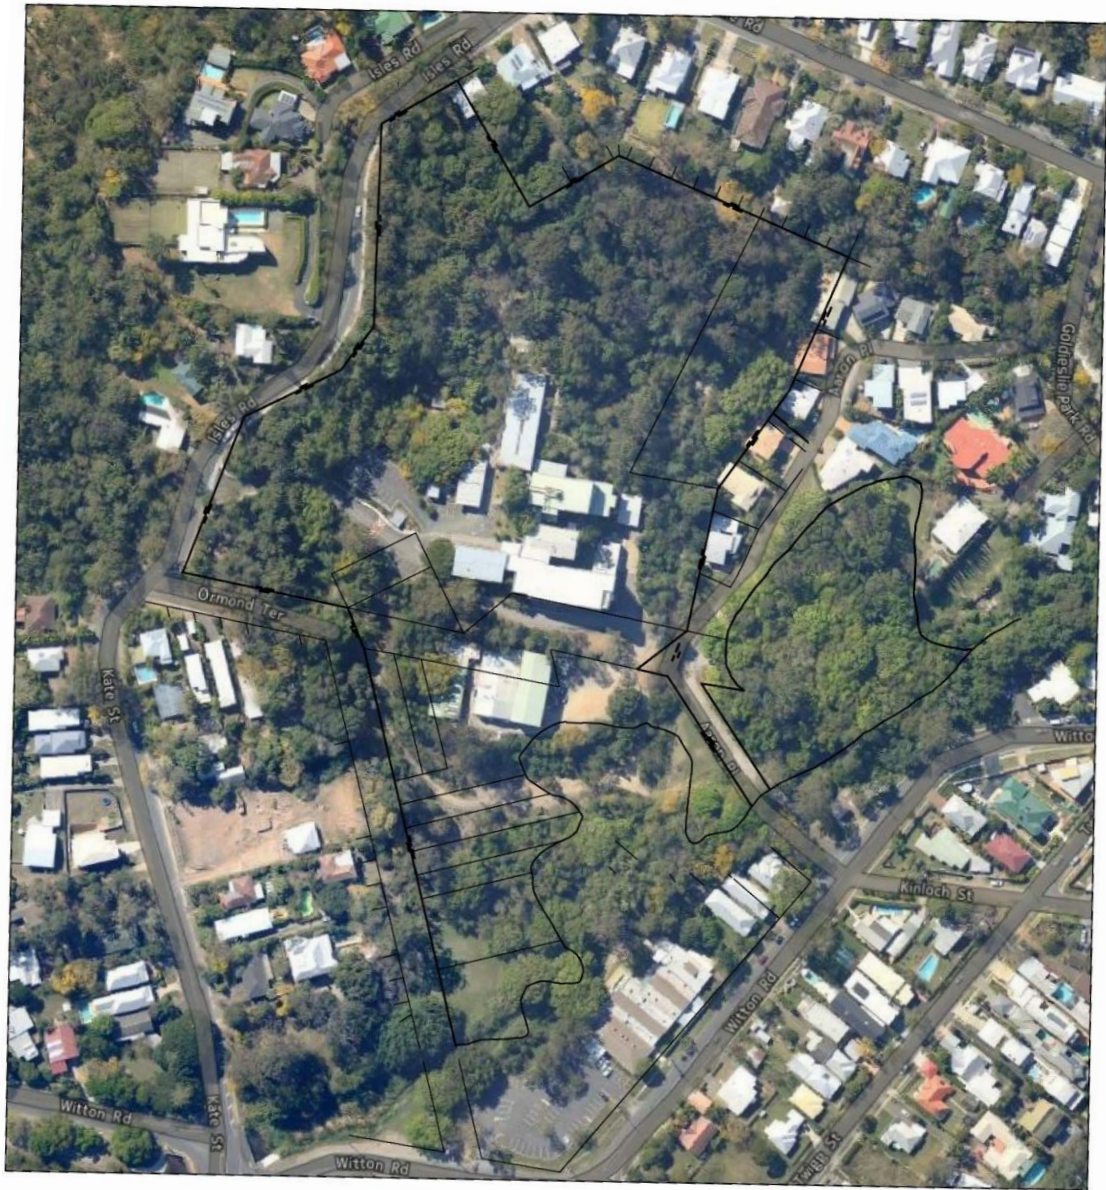
Figure E.1. 2013 aerial photograph of the UQEM with approximate overlay of notified lots.

Appendix E provides a recent aerial photograph with the notified lots marked for reference.
