PUBLIC REPORT 2011

The University of Queensland

Part 2 - Assessment Outcomes

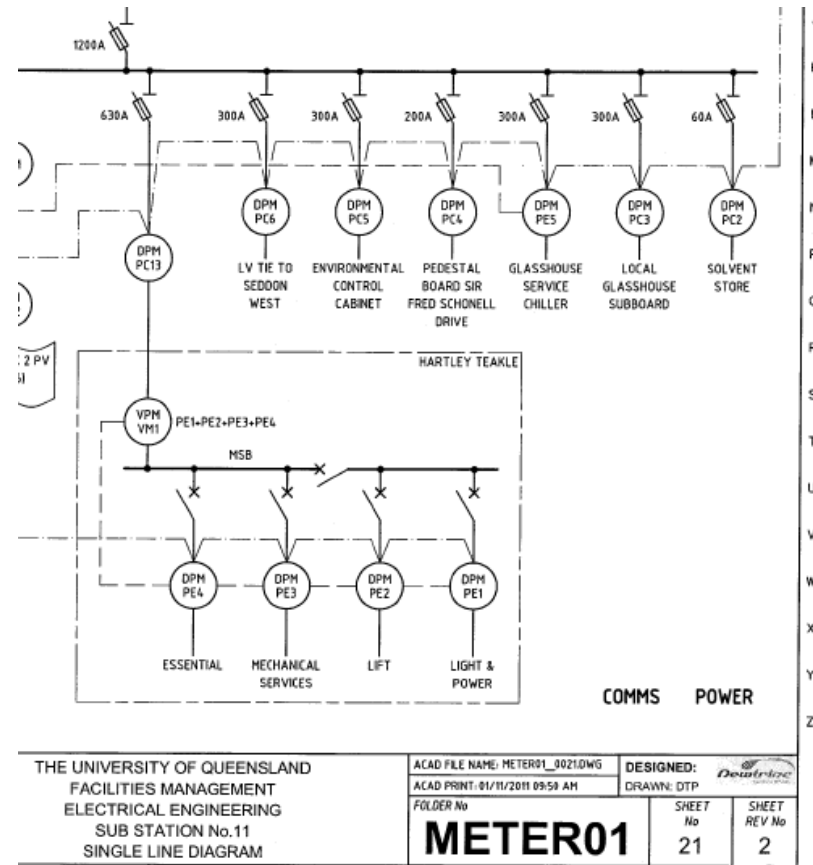
Figure 2: Metering Schematic Extract - Example

Metering schematics were prepared showing the position of meters on the high voltage and low voltage networks and hence the loads or sub-networks metered. The schematics contain a communication layer so that it is possible to visualise the relationship of meters to the IT network. Accurate metering schematics have enabled the identification of opportunities to create virtual meters and to cover gaps in the network. The schematics have been organised into a library linked directly to the meter management database (outlined shortly). Users can toggle between meter attributes in the management database and a visualisation of meter location and IT arrangements. **Figure 2** shows an example of metering schematic (note the virtual meter middle left).

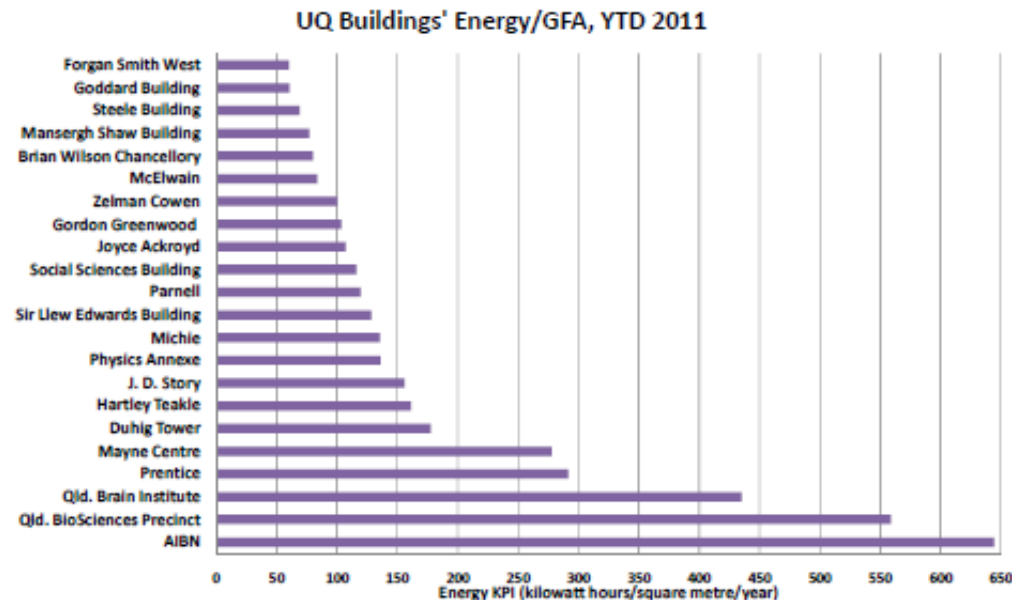
Figure 4: Sample Building Benchmark Report – kWh/m² GFA - 2011 YTD

UQ already has a system of data acquisition, retrieval and rendering that enables tables and graphs of energy consumption and trends to be produced using the data from some meters. The system can be used to produce benchmark reports like the one shown in **Figure 4** for example, but a considerable amount of manual handling of data is needed. During 2011/12, UQ is planning to install a new software front end and undertake the system integration necessary to create a user friendly reporting system – a system that can be readily used by students, researchers, facilities engineers and consultants. This will improve overall visibility of the system and this in turn is expected to lead to identification of a greater number of energy efficiency opportunities than is presently possible.

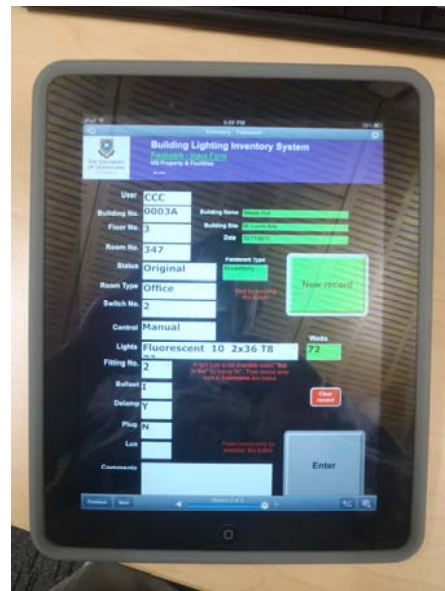
Figure 5: Lighting Technologies - iPad Based Field Data Entry

Consequently a lighting survey methodology was developed. Initially a system using handwritten records and entry to Excel was used. Then to increase productivity and reduce entry error, an iPad based field data entry system was developed (**Figure 5** below). The full system was then tested from survey through to retrofit at a full scale building scale. A combination of lighting improvement measures were applied to the JD Story Building, one of the main administration buildings on the St Lucia campus. This was highly successful. 122 T8 tubes and 77 50H lights were replaced by LED and T5 tubes, respectively.

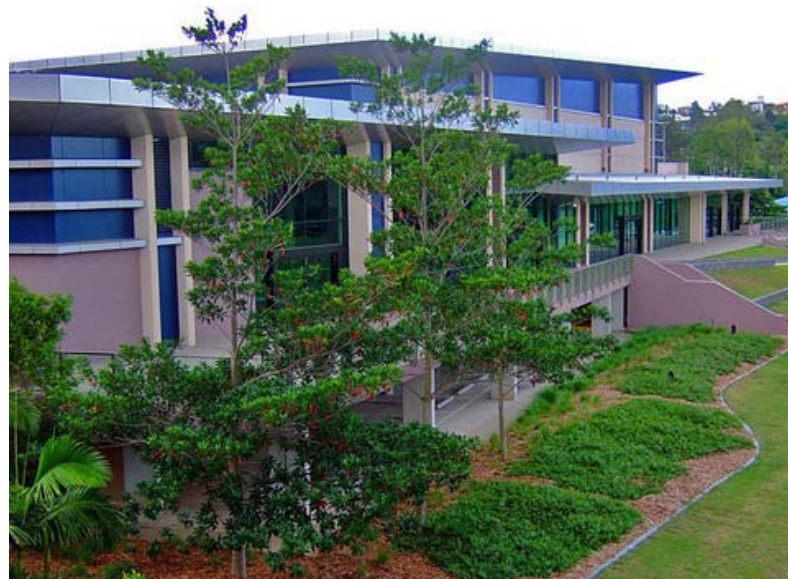
Figure 6: UQ Centre Eastern Facade

The eastern facade of the UQ centre is almost entirely glass and is exposed to the summer sun from just after sunrise to almost 11am. Mirror window film was examined as a heat load reduction strategy. A key consideration was to avoid sun strike or glare from reflected sunlight for a number of key third parties: bus drivers that used a bus stop and turning zone at the UQ end of the Eleanor Schonell Bridge; people driving vehicles (including bicycles) along Sir William McGregor Drive; sports persons and spectators on adjacent playing fields; and the residents of houses on the opposite side of the Brisbane River. A sun path and reflection analysis was conducted and this indicated that any problem was confined to a small geographic area and a short time period very early in the morning.

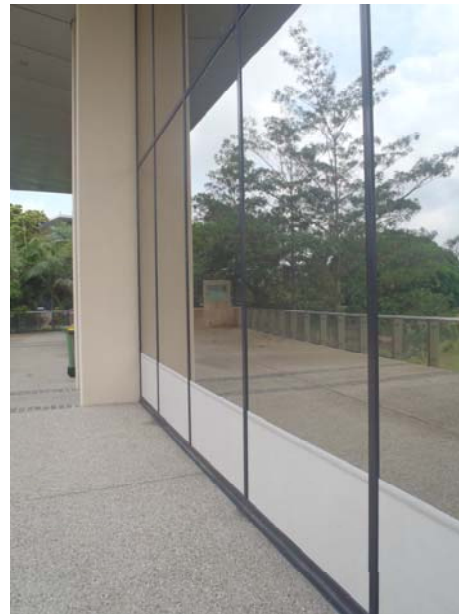
Figure 7: 800mm High Bird Band

A trial installation of the film revealed another type of problem, however. UQ prides itself on the prolific wildlife that coexists with the human activities on the St Lucia campus. Unfortunately Spur Winged Plovers (or Masked Lapwings) decide to attack their reflections in the mirror film. As attacks were launched from ground level, an 800mm high bird band – a see through perforated film - was placed over the bottom of the mirror window film. This band retained the thermal performance of the mirror film but broke up the reflected images thus deterring further attacks by the birds (Please see **Figure 7**).
